## Information Data Sheet

### Blistering and Delamination of Roof Paint Coatings

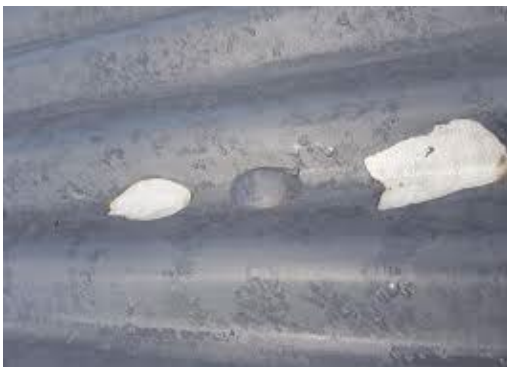
- They are approximately 20 years of age
- They were originally factory painted Colour Steel roofs
- Often, but not always, it is the first repaint of these roofs and they are only being painted as the original colour has faded or a change of colour is desired
- The blistering is at the interface between the original primer and the bare galvanised iron
- Blistering was NOT noticed to the existing coatings prior to repainting
- The painting work has been carried out competently with pressure washing prior to painting, full coats of paint applied and quality roof paint products used

Adhesion testing of the roof coatings, carried out often right next to the blistered area, show the paint coatings are adhering to the previous paint coats. The blistering and delamination of the paint coatings is almost impossible to predict as can be seen by the adhesion testing noted.

*Photo Image – blistered roof coating showing failure at interface between original factory applied primer and roofing iron*

Remediation of this work will be extremely difficult as the affected areas will need to be entirely stripped of the paint coatings, primed and repainted. It may be cost effective to replace individual sheets of roofing iron rather than strip the paint coatings.

**NOTE:** Extreme caution should be used when considering repainting roofs of this vintage. Painting contractors should make the likelihood of this problem known to the building owner when quoting work and tag all quotations that blistering of this nature cannot be foreseen. The painting contractor should also advise that they are not responsible should this blistering take place.
