Information Data Sheet

Surfactant Leaching on Newly Painted Exterior Surfaces

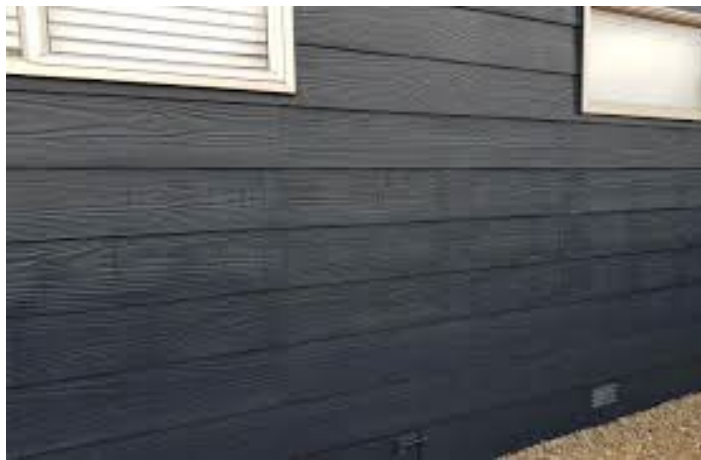
Surfactant leaching is a common occurrence with freshly applied paint coatings. The soapy deposits come to the surface of the paint coating when they are exposed to humid conditions. The leaching takes on the appearance of a clear or tannish colour stain, often running down the surface. The staining can be sticky to touch. While it can be found on freshly applied paint coatings of any colour, it is especially common on dark colours where large amounts of colourant have been used to deliver the desired colour.

This leaching is not a painting workmanship issue and is unlikely to be happening because the painter has done something wrong or has used low quality paint.

Surfactant leaching can become noticeable after only a few days. Once the surfactant is visible it should be washed off with a soft brush and warm water before rinsing with a garden hose to remove the soap lather. The washing down may have to be done on a couple of occasions until all the surfactant is completely released.
