Information Data Sheet

Common Paint Problems: Efflorescence

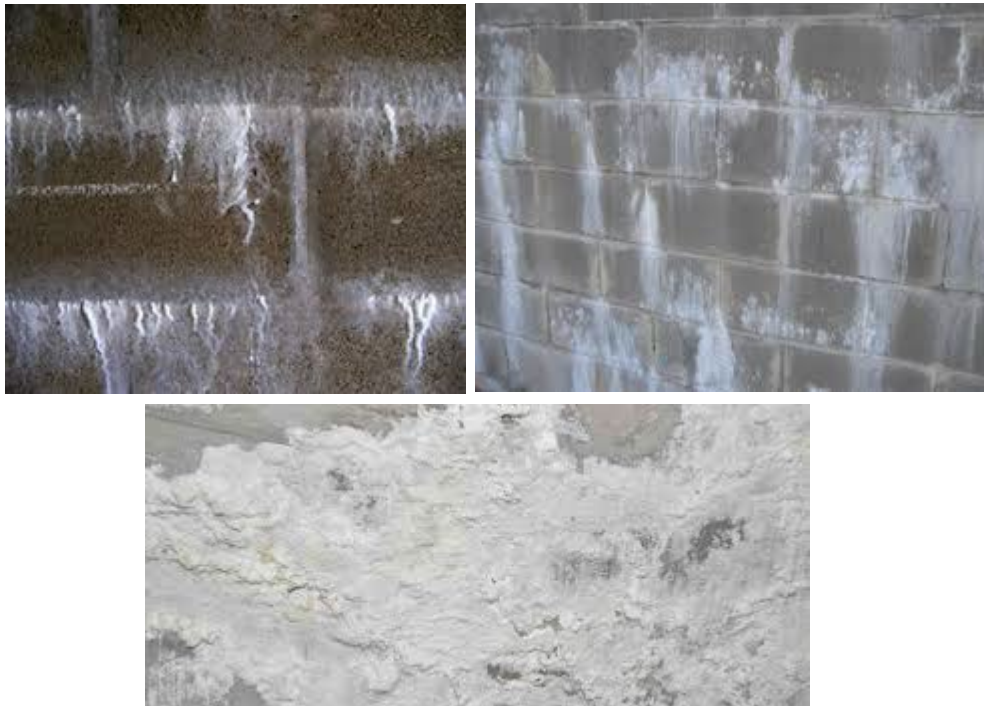
What is Efflorescence? Efflorescence appears as a white deposit of mineral salts on the face of concrete walls and/or floors. Efflorescence usually appears in underground car park areas and other subfloor areas. Efflorescence is caused by moisture ingress. As the moisture enters and moves through the wall or floor, it dissolves mineral salts present in the cement. This mineral salt solution eventually finds its way to the surface of the concrete. As the water evaporates, it leaves behind a white deposit of mineral salts on the surface.

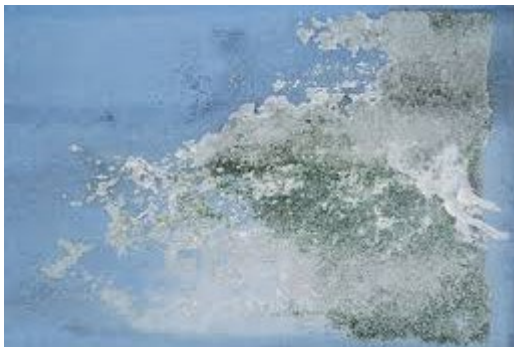
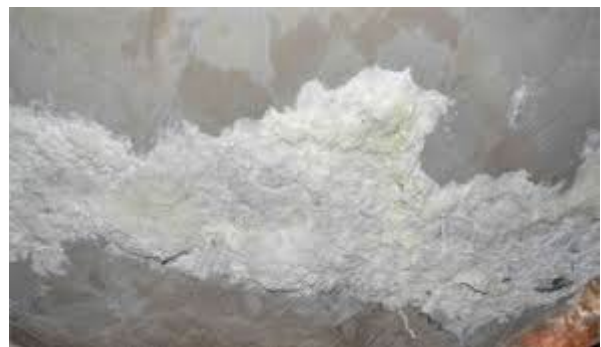
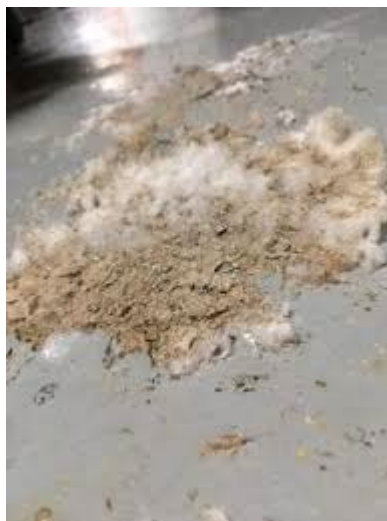
Even if all the efflorescence is thoroughly removed, moisture will still be present in the concrete. Where there is moisture in concrete, there is hydrostatic pressure. Hydrostatic pressure will force the moisture out of the concrete and collect between surface of the concrete and the coating system, forming blisters under the coating and causing the coating to delaminate.

Can Efflorescence be painted over? The short answer is no. Any efflorescence on the surface will provide a poor, friable base for coatings, preventing effective adhesion from occurring.

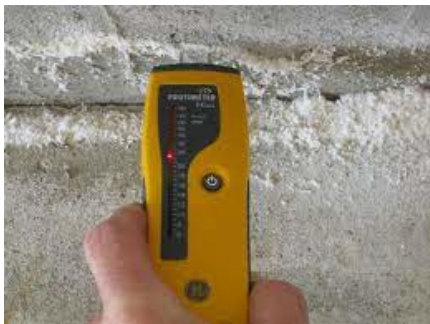
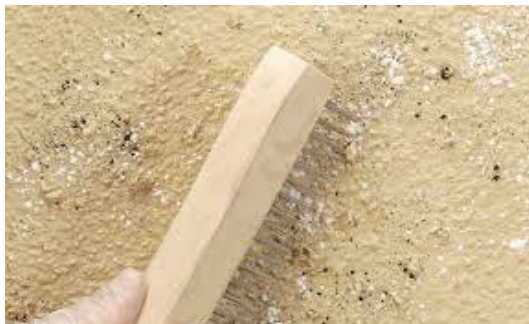
1. Ensure that the concrete has been cured for at least 30 days.
2. Remove all efflorescence, other surface contaminants and loose material. Any one of a number of techniques may be used, including, but not limited to, wire brushing (hand or power tool), dry abrasive blasting or high-pressure water jet. (The use of water will reintroduce some moisture into the concrete and can cause some reappearance of efflorescence. Allow concrete to dry, and wire brush any residual efflorescence). Check for any reoccurring efflorescence, as this may indicate a leakage problem.
3. Check moisture content of concrete. This should be <10%, as measured with a standard moisture meter. If so, the concrete is ready to coat. If not, go to Step 4.
